STRUCTURAL STABILITY EVALUATION, POKEGAMA DAM.(U)

MISCELLANEOUS PAPER SL-80-15

## STRUCTURAL STABILITY EVALUATION POKEGAMA DAM

September 1980

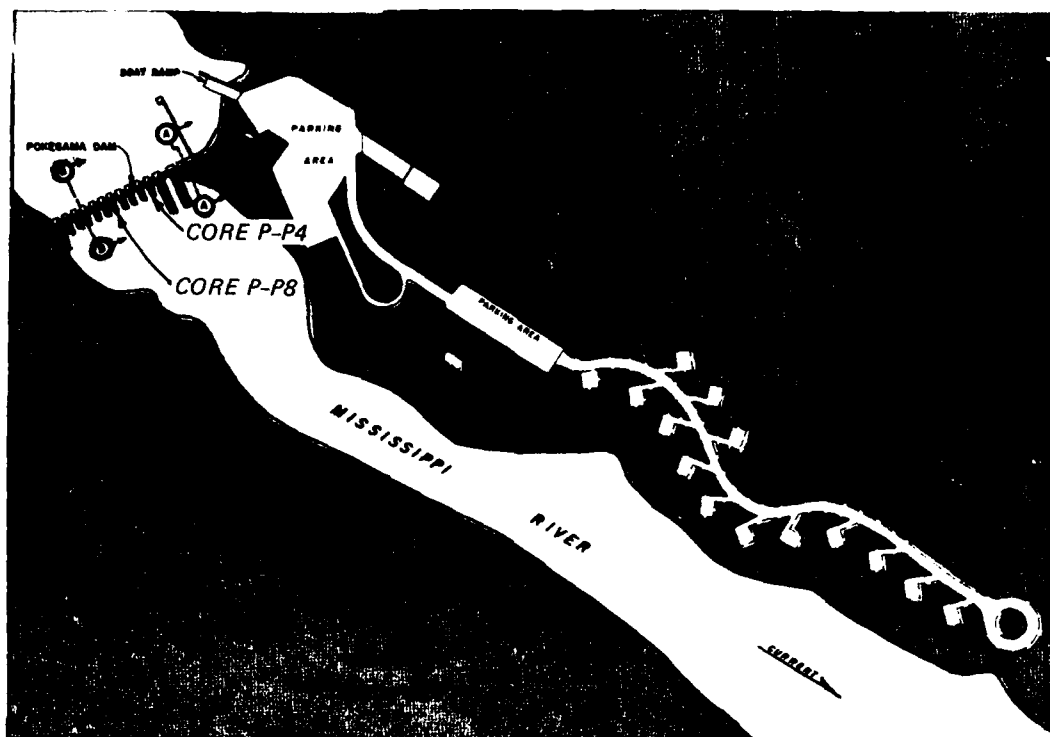
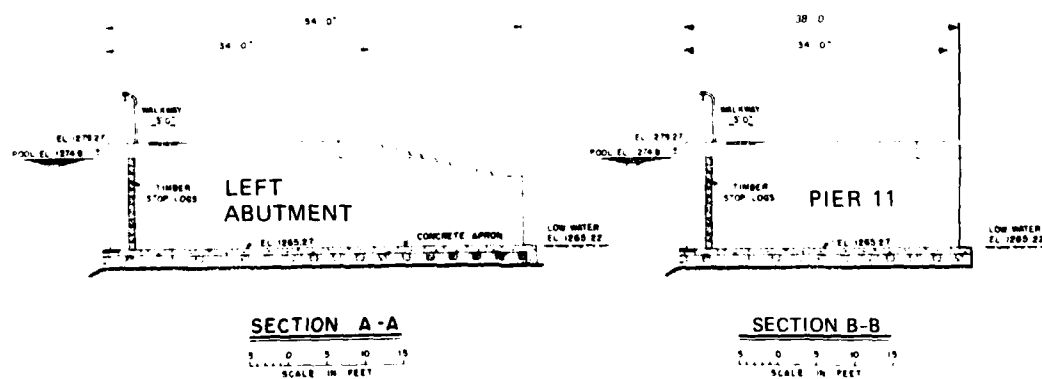
Figure 3. General construction layout, Pokegama Dam

10. The objective of this study is to evaluate the stability of the concrete control structure. For this evaluation two cores were drilled through the dam (Figure 3) and into the foundation. The cores were examined and the structural stability of the dam was evaluated.

13. A typical drilling operation is shown in Figure 6. The core holes were located at approximately third points of the dam in pier 4 (P-P4) and pier 8 (P-P8) to obtain cross-sectional material properties. The locations of the two core holes are presented in Figure 3. The cores being obtained were changed from 4-in. cores to NX cores to eliminate the wear and replacement costs of an excessive number of diamond bits.
